## Guided Bone Regeneration with BoneHeal™ Membrane after Explantation of Fractured Implant: Case Report

Implantoprosthesis rehabilitation has become the main method to reestablish totally or partially edentulous patients, with a high success rate. However, some complications can cause implant loss. The main one is periimplantitis, with bone loss around the osseointegrated implant. However, implant fractures or incorrect implant position may compromise implant rehabilitation and require implant removal. Several techniques can be used for implant explantation, and the dental surgeon should opt for the easiest and most conservative technique, ensuring the greatest preservation of remaining bone tissue and aiming at the future reinstallation of another osseointegrated implant. Sometimes, associated Guided Bone Regeneration techniques may be necessary in conjunction with future implant installation, using various procedures or biomaterials. The purpose of this article is to present the case of a patient who underwent explantation of a fractured implant. A polypropylene membrane (BoneHeal™) was used and an implant was reinstalled 8 months after explantation.

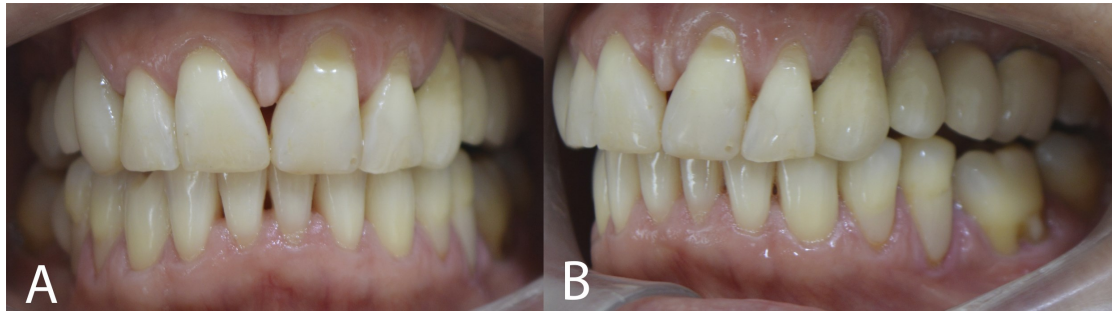
Clinically, mobility of the metal-ceramic crown over the implant was observed in the region of tooth 25. Periodontal disease and suspected periimplantitis were not observed (Figure 1).

**Figure 1:** Initial clinical aspects: frontal (A) and left lateral (B) views.

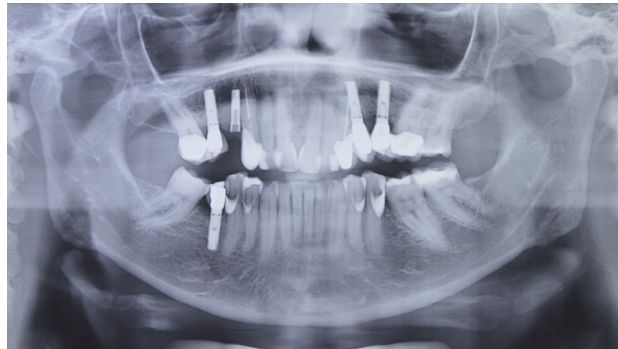
Radiographically, absence of bone loss and periodontal and periimplant diseases were observed (Figure 2). However, cone beam computed tomography revealed fracture of the implant buccal wall and the external hex connection of implant 25 (Figure 3).

**Figure 2:** Initial radiographic aspects (panoramic radiograph).

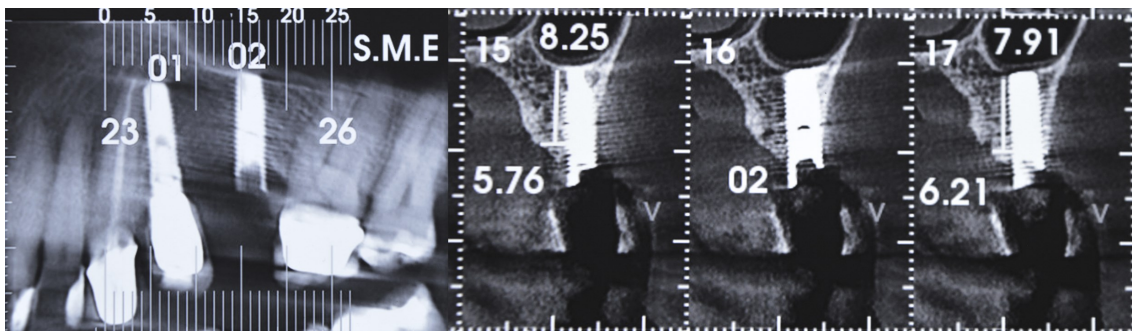
**Figure 3:** Computed tomography presenting fracture of the implant buccal wall and the external hex connection of implant 25.

Implant explantation was indicated, followed by the use of a polypropylene membrane for bone preservation and clot maintenance, with a view to future osseointegrated implant installation and subsequent implantoprosthesis rehabilitation. After due explanations, the patient agreed to the procedure.

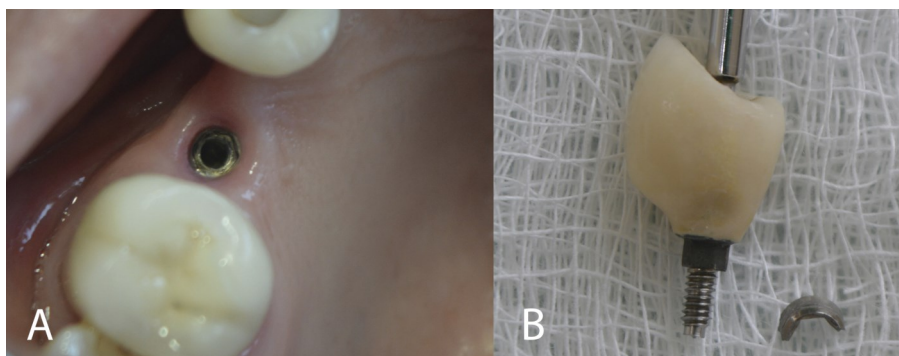
Upon removal of the prosthesis, the fracture and the removal of the connection fragment was noted (Figure 4).

**Figure 4:** Intraoral clinical aspect of implant fracture (A) and removed fragment (B).

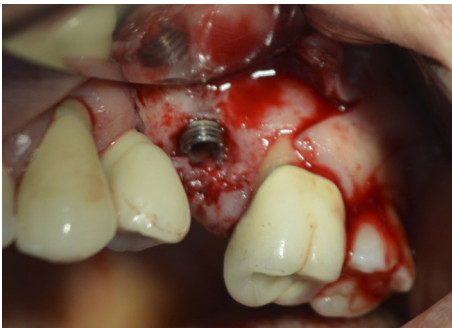
**Figure 5:** Mucogingival flap and implant exposure.

After local anaesthesia, intrasulcular and over the bone crest incisions and mesial and distal relaxations were made, flapping the mucogingival flap and exposing the implant (Figure 5). In an attempt to use the counter-torque technique associated with small bone wear parallel to the long axis of the implant, the implant was removed (Figures 6 and 7). The region was abundantly curetted and washed with saline, with bleeding present. The polypropylene membrane (BoneHeal™, São Paulo, Brazil) was adapted and installed over the surgical site and sutured. Analgesic, anti-inflammatory and antibiotic drugs were prescribed to the patient.

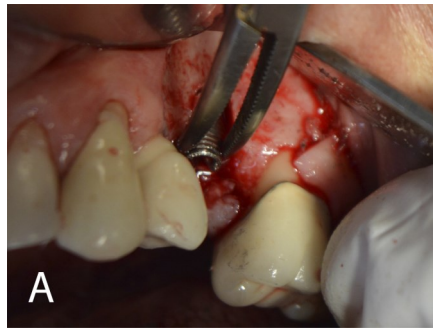
**Figure 6:** Seizure of the implant with needle holder (A) and implant explantation (B).

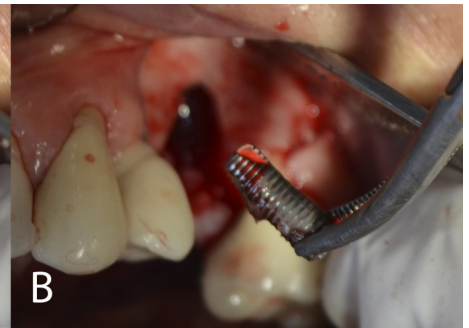
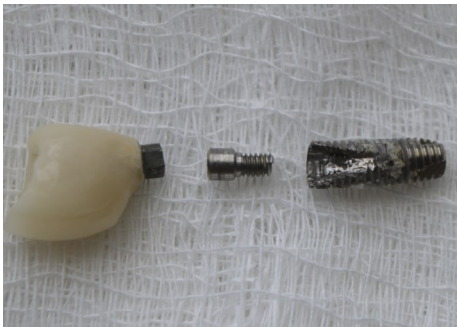
**Figure 7:** Implant removed.

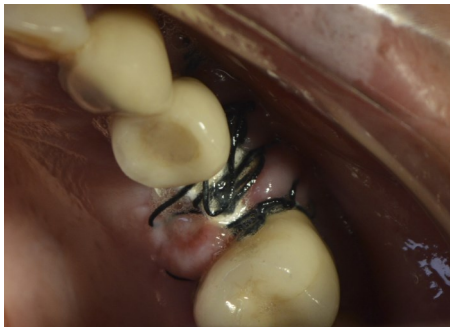
**Figures 8:** Polypropylene membrane and sutures after 15 days.

At the subsequent visit, after 15 days, the membrane and sutures were removed (Figures 8 to 10). No complaints or complications were reported.

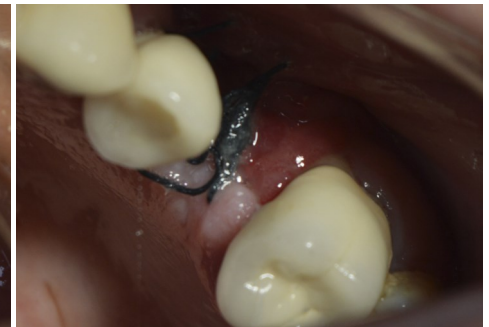
**Figures 9:** Polypropylene membrane removed after 15 days.

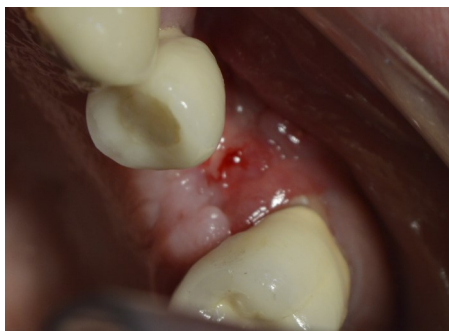
**Figures 10:** Remaining sutures removed after 15 days.

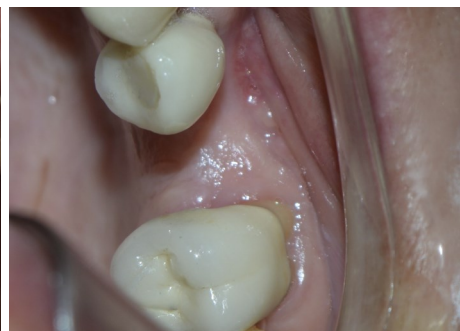
**Figure 11:** Preservation of bone tissue and gingival mucosa after 8 months.

After 8 months, the installation of the osseointegrated implant was planned. Clinically, the preservation of bone tissue and gingival mucosa was observed (Figure 11), favoured by the use of the polypropylene membrane. Computed tomography revealed preservation of bone remnant, compared to the tomography before explantation (Figure 12).

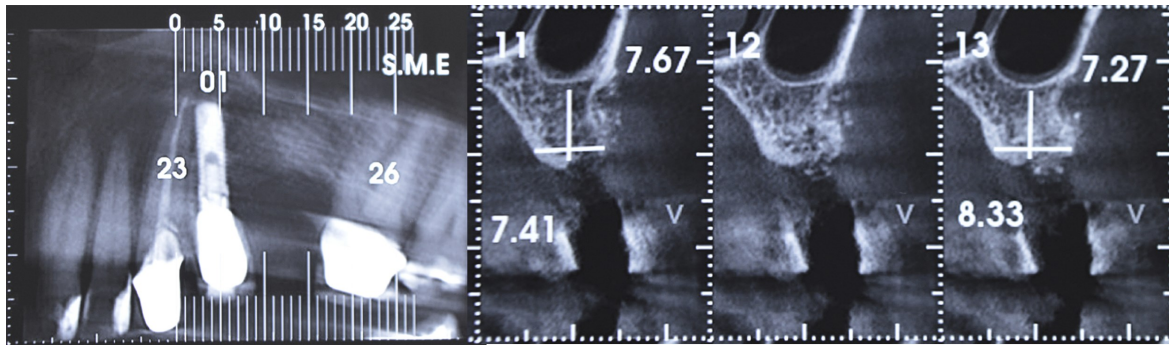
**Figure 12:** Computed tomography revealed preservation of bone remnant, compared to the tomography before explantation.

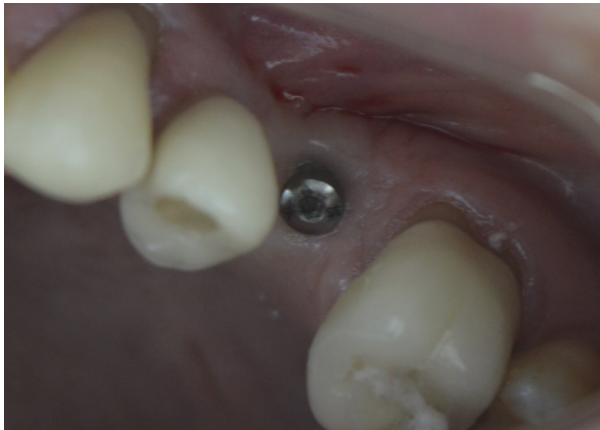
**Figures 13:** Morse cone implant installed.

A 3.8 X 10mm Morse Cone implant (SIN Implantes, São Paulo, Brazil) was installed. After the osseointegration period (8 months after installation), the screw-retained implant prosthesis was made (Figures 13 and 14).

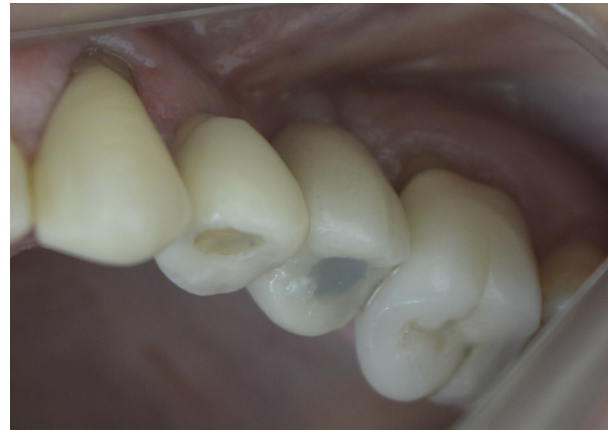
**Figures 14:** Screw-retained implant prosthesis.

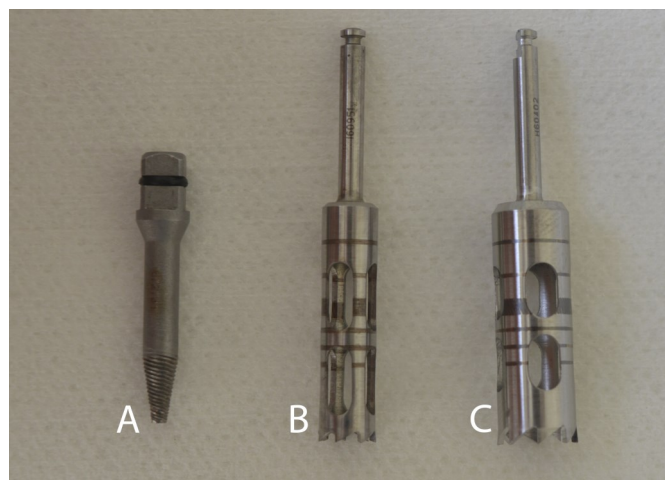
**Figure 15:** Implant Retrieval (A) and trephines (B and C) and can be employed.

The application of counter-torque in an anti-clockwise direction to disrupt osseointegration is the most commonly used and the most conservative technique, allowing removal of the implant and removal of little or no bone. When implant explantation is not possible, with fractured implants or prosthetic components, or with a torque greater than 200Ncm, the use of trephines is required. Additionally, the use of Implant Retrieval can also be employed (Figure 15)<sup>1-3</sup>.

The explantation technique using trephines can be performed with or without flaps, and with immediate or delayed replacement implantation. Obviously, the flapless technique requires a computerised tomography scan prior to the execution of the technique. And late implant installation is considered the gold standard, precisely because of the need to achieve primary stability of the replacement implant. In the case of hollow drills with an internal diameter greater than the implant diameter, the use of trephines is clearly more aggressive than the counter-torque technique<sup>1-3</sup>.
